**SCREENING SITE INSPECTION
SITE EVALUATION REPORT FOR
MASTER METALS, INCORPORATED
CLEVELAND, OHIO
OHD 097 613 871**

**U.S. ENVIRONMENTAL PROTECTION AGENCY
Site Assessment Section
Chicago, IL 60604**

Work Assignment No.	:	29-5JZZ
EPA Region	:	5
Date Prepared	:	June 30, 1994
Contract No.	:	68-W8-0084
PRC No.	:	030-002983
Prepared By	:	PRC Environmental Management, Inc.
Contractor Project Manager	:	Julie Kaiser
Telephone No.	:	(312) 856-8700
EPA Work Assignment Manager	:	Jeanne Griffin
Telephone No.	:	(312) 886-3007

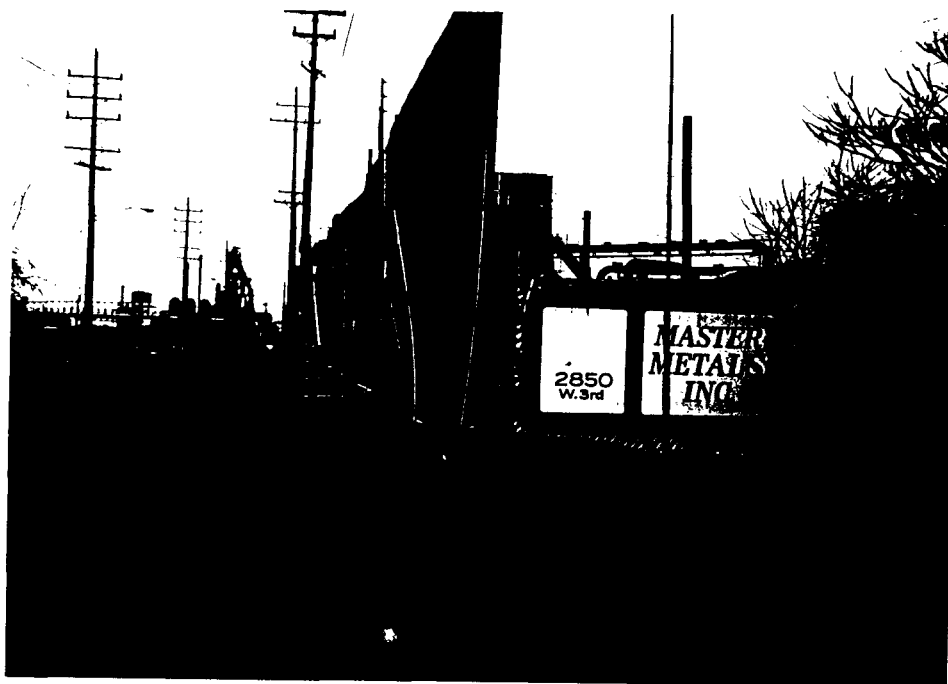
Photograph No. 3

PRC noted that Air Monitoring Station 39-035-0055 and its collocated air monitoring station were located outside MMI's main gate east of the corrugated fence and sprinkler system and west of West Third Street (see Photograph No. 3). Air Monitoring Station 39-035-0057 was located at the south end of the MMI property between West Third Street and the MMI perimeter fence (see Photograph No. 4). Air Monitoring Station 39-035-0062 was located across from the MMI main gate on the east side of West Third Street (see Photograph No. 5). Air Monitoring Station 39-035-0061 and its collocated air monitoring station were located south of MMI on City of Cleveland property south of West Third Street. An abandoned asphalt company still remains on this property (See Photograph No. 6). All the air monitoring stations appeared to be in good condition.

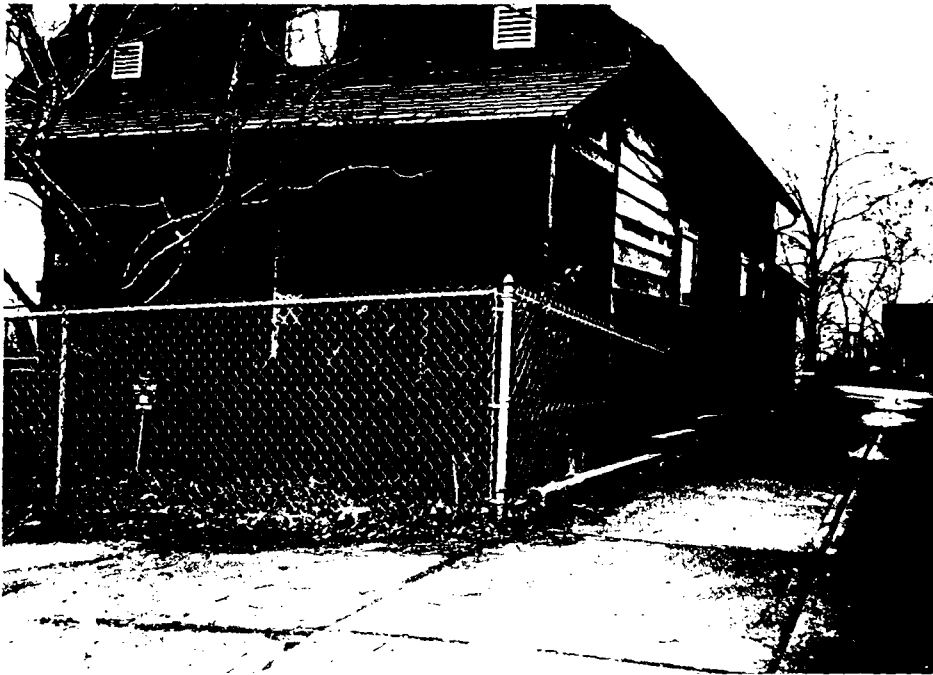
Photograph No. 7

The Ogle residence is located approximately 1 mile southwest of the site on a terrace overlooking LTV Steel. PRC noted that yellow flagging had been posted along the southern border of the Ogle property. A small yard devoid of vegetation was located between the Ogle home and their cyclone fence (see Photograph No. 7). A yard along the side of the Ogle home was filled with gravel and rock (see Photograph No. 8).

Description: This photograph shows the front yard of former Ogle residence; note the yellow flagging behind the house.

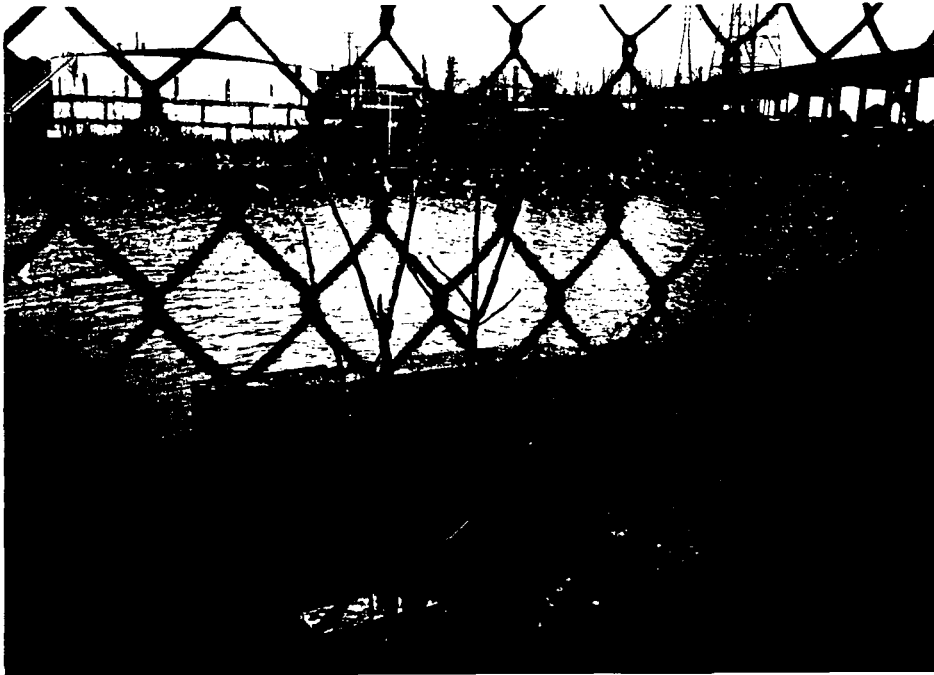
Photograph No. 11

Description: This photograph shows the probable point of entry into the Cuyahoga River from the Mary Street Pumping Station.
